Volvo Car Corporation

Instructions for qualified inspection personnel, assessments of transport damages.

Vehicle inspection Procedure

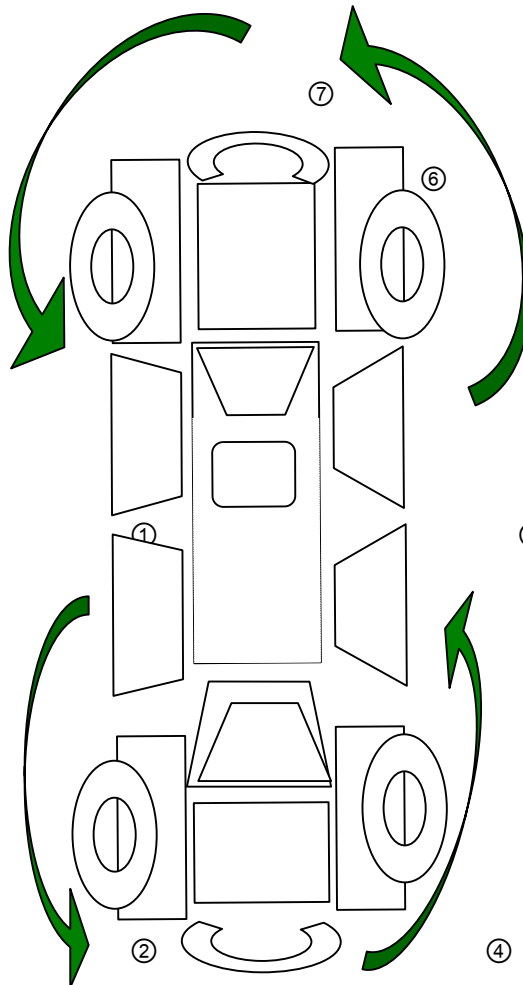
The vehicles must be thoroughly inspected by walk around the vehicle and the items listed on the drawing (page 3) must be checked, also common sense must be used when inspecting the vehicle, such as look from all different angles and on all possible places, or normal travel stain conditions, and cars to be checked in condition they arrive in. Observe surface by through-looking, meaning inspecting at a 20 to 30 degree of angle to the surface.

7) Inspect :

Hood, Grill, Front Bumper, headlights, molding, spoiler, undercarriage

8) Inspect :

Left Side Windshield & Wiper
Left Front Fender
Left Front Tire & Wheel

Moldings
Left side Hood & cowl
Left front Pillar post

1) Inspect:

Left side roof
Left side door & Glass
Left rear door
Left center post
Left side rocker PNL
Molding
Under Carriage

2) Inspect:

Left Rear quarter PNL
Left side rear Glass
Left Side trunk

Left rear pillar post
Molding
Left rear tyre & Wheel
Under Carriage

3) Inspect

Trunk, Tail Light,
Rear Bumper & molding
Under carriage & Exhaust pipe

6) Inspect :

Right Side Windshield & Wiper
Right Front Fender
Right Front Tire & Wheel

Moldings
Right side Hood & cowl
Right front Pillar post

5) Inspect:

Right side roof
Rightside door & Glass
Right rear door
Right center post
Right side rocker PNL
Molding
Under Carriage

4) Inspect:

Right Rear quarter PNL
Right side rear Glass
Right Side trunk

Right rear pillar post
Molding
Right rear tyre & Wheel
Under Carriage
